NORTH HEMPSTEAD BEACON HILL BLUFFS STABILIZATION PROJECT

August 5, 2019

What is the Beacon Hill Bluff Project?

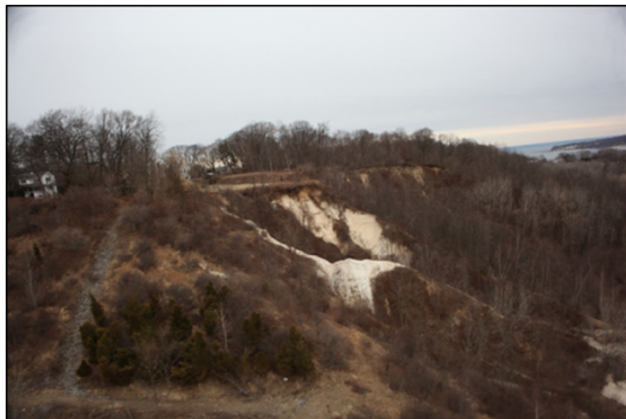
This photo, taken from the Harbor Links Golf Course, illustrates the erosion that is visible on the Beacon Hill Bluffs.

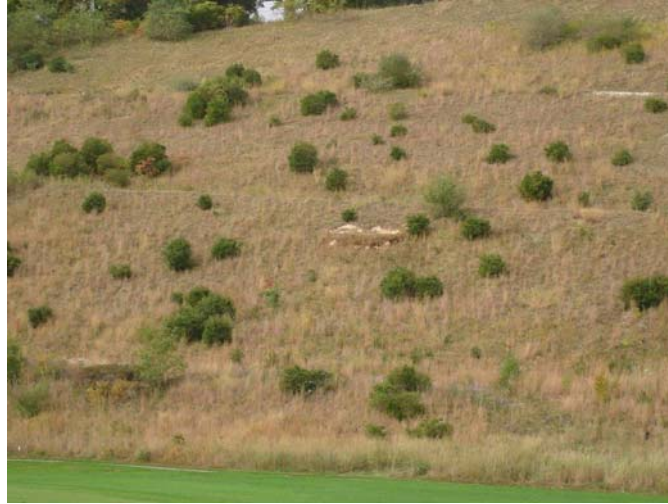
In 1997 the bluffs adjacent to the Harbor Links golf course were stabilized. Pictured below is the result:

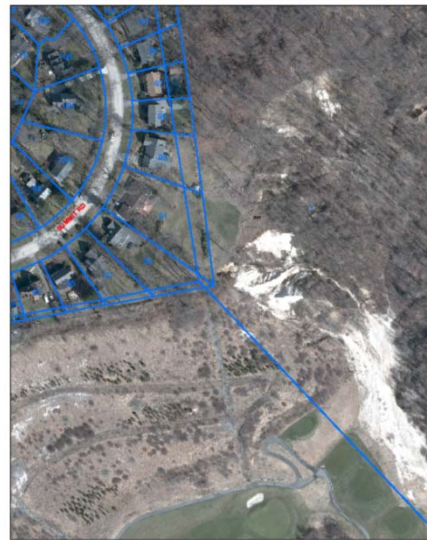
This photo shows the flow of sand flowing down into Harbor Links Golf Course

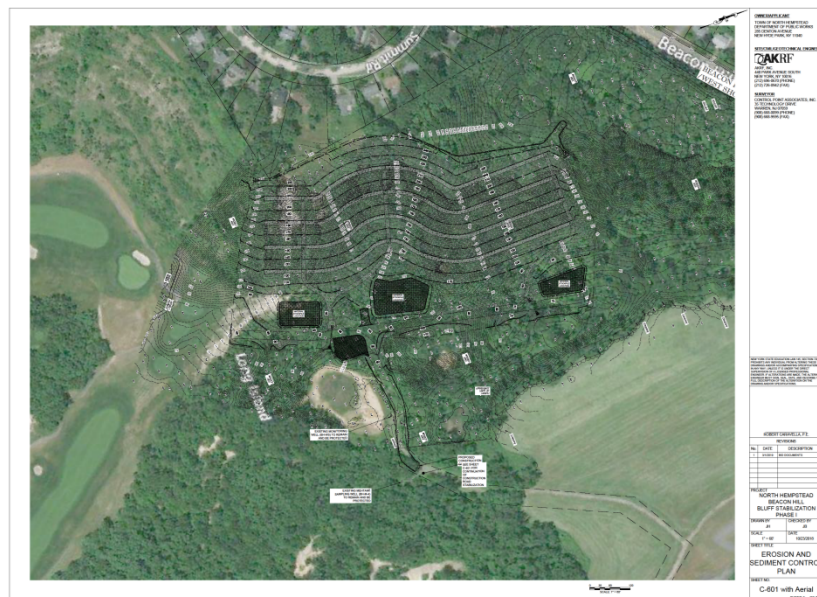
An aerial view showing the work to be performed by the contractor

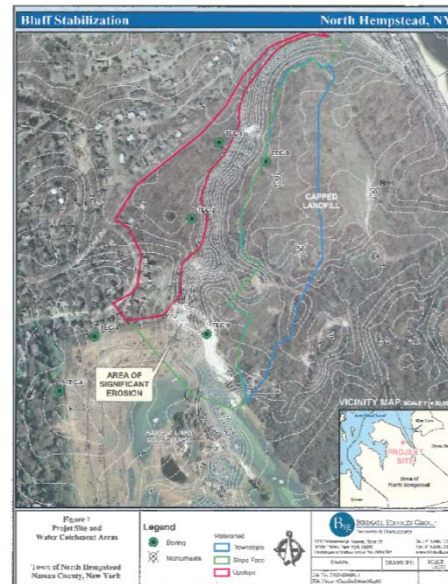
The red line in this aerial view shows the most severely eroded section of the bluff.

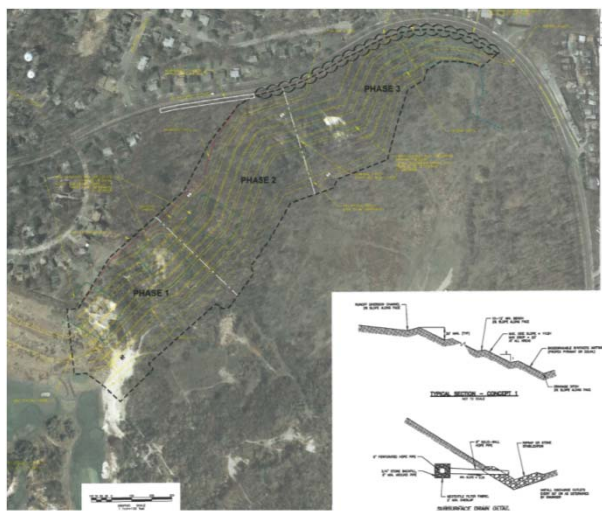
The restoration of the bluffs has been divided into multiple phases.

The first phase, which we are hoping to start this month, will stabilize the most damaged area.

Phase 2 will address the area North of Phase 1.

Phase 2 construction is planned for next year as per the adopted 2019 Capital Plan.

Phase 3 area was determined to be safe at the moment and requires no stabilization at this time.

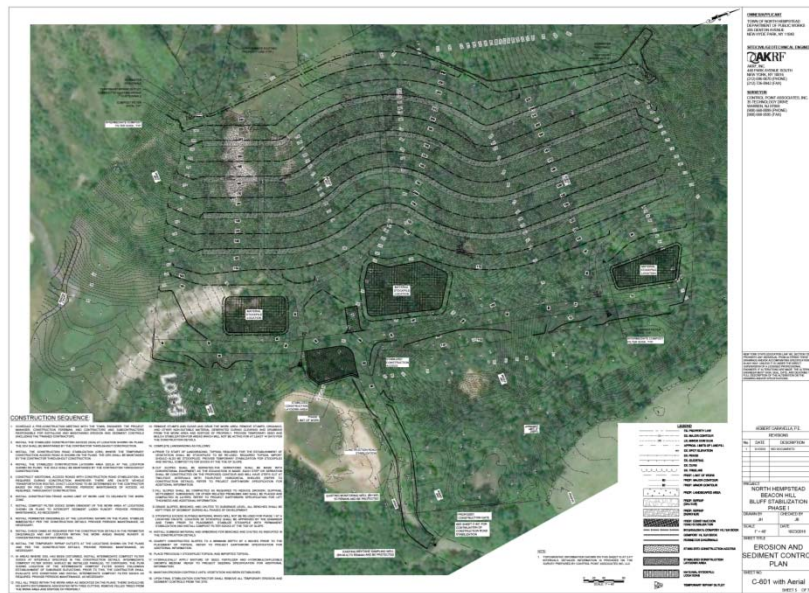
Another aerial view showing the work to be performed by the contractor.

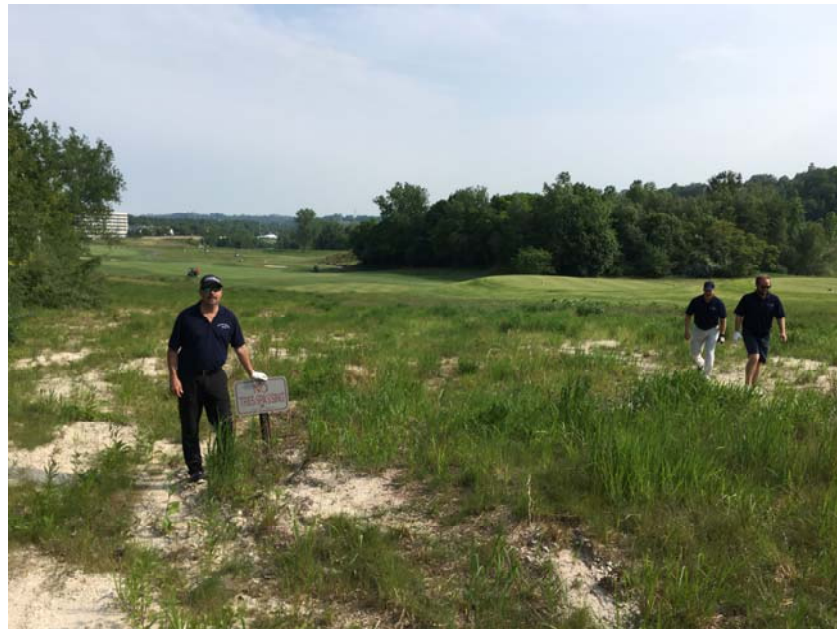
The results of the flow of eroded sand from the Beacon Hill Bluffs is shown here in this dramatic photo of a sign that once stood at 8-foot high, is now buried in about 6-feet of sand. DPW Commissioner Paul DiMaria examines the conditions.
